## Church of the Holy Virgin Monastery

CHURCH OF THE HOLY VIRGIN  
MONASTERY,  
Goranxi, Dropulli region

453

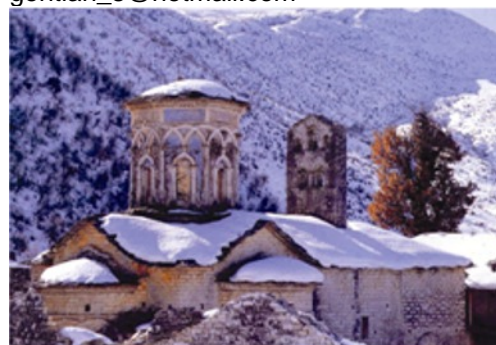
Bad: deterioration of structure and roof covering.

The deterioration of roof covering will cause the presence of humidity in the church, threatening the frescoes.

The priority level for intervention is *high*.
