The Church of Kozara

THE CHURCH OF KOZARA, Berat

34

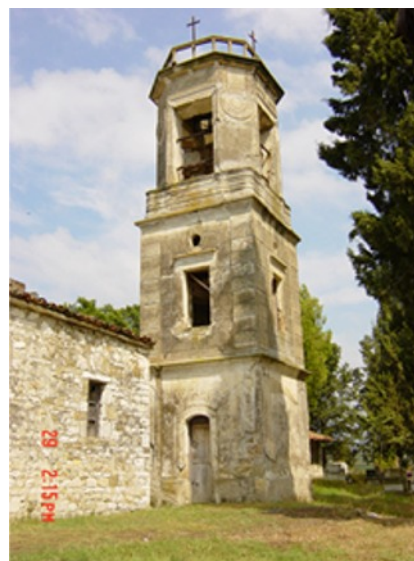
Poor: inside walls are fissured; the structural capacity of the construction is reduced. In the southern part of the nave wall, a horizontal fissure and a 25 cm inclination in the upper part are visible. The monument suffers from humidity because of roof deterioration. The decorative ceiling is rotted and has lost its characteristics. Wall frescoes are also seriously damaged. One of the belfries is destroyed.

The Church of Kozara is a three-aisled basilica type church, representing the traditions of the Orthodox community in the Myzegeja region. The state of conservation is bad, there are numerous fissures in the walls reducing the structural capacity of the construction. The roof is also damaged. The priority level for intervention is *high*.
