The Fethija mosque

Name of organisation
compiling the information:
Commission to Preserve National
Monuments

<u>Name and address of bulding(s) or site:</u>	THE FETHIJA MOSQUE, Bihać
<u>Inventory reference number(s):</u>	08.2-6-795/03-8
<u>Ensemble type(s):</u>	Monumental, architectural ensemble consisting of a mosque, harem (courtyard/burial ground) and nine gravestones.
<u>Building type(s):</u>	Sacral building
<u>Main date(s):</u>	13 th or late 14 th century
<u>Current use(s):</u>	Mosque from 1592 to the present day Church from the 13 th or late 14 th century to 1592

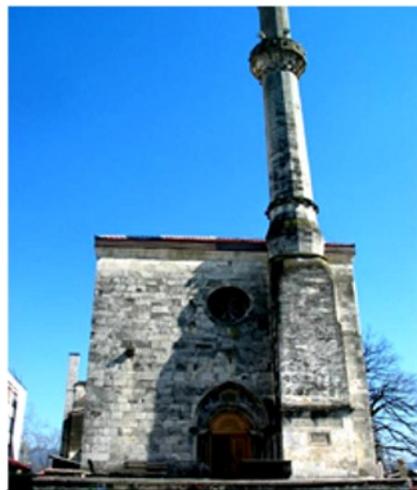
In 2000, the Institute for the Protection of the Cultural, Historical and Natural Heritage of Bosnia and Herzegovina inspected the condition of the building, and found that the minaret of the Fethija mosque was cracking alarmingly along the joints, both horizontally and vertically, along the barrel of the minaret up to the top, which is threatening the stability of the minaret. The cracks are visible although the whole of the body of the minaret which is covered with a strong mixture of cement and terrazzo, having an aggressive effect on the stone. Local inhabitants are contributing, by their works on the interior, to the very bad condition of the building.

1. the wooden *mahfil* and its access staircase have been pulled down
2. the floor slabs have been pierced and eight reinforced concrete free-standing bases measuring 2.20 x 2.20 x 0.60 metres have been concreted in
3. on each of the reinforced concrete bases an octagonal reinforced concrete pillar has been set with cross-section dimensions of 40 x 40 cm and a height of 3.10 m
4. shuttering for horizontal tie beams has been laid across the pillars with part of the shuttering for a reinforced concrete floor slab.

Project for urgent protection measures from further deterioration needs to be done, as well as projects for next phases of protection – project of sanitation, conservation and restoration.

- a technical survey of the monument,
- research works including a study of the stability and structure of the walls of the building and the minaret, and proposed repairs,
- research works to reveal the interior original painted layers (around the *mihrab* and on the *mihrab* wall),
- research works on the *mahfil* of the mosque followed by a project to repair the *mahfil* using original parts,
- repair of damage to the entrance area of the building – steps and landing – and repair of the damage to the wall surrounding the complex,
- conservation of the tombstones from the mosque harem.
