Hamмам, Mitrovicë

Territory:
KOSOVO/UNMIK

<u>Name and address of building(s) or site:</u>	HAMMAM, Mitrovicë
<u>Inventory reference number(s):</u>	Being processed
<u>Building type(s):</u>	Public building, Hammam
<u>Main date(s):</u>	17 th century
<u>Current use(s):</u>	Archaeological and ethnological Museum

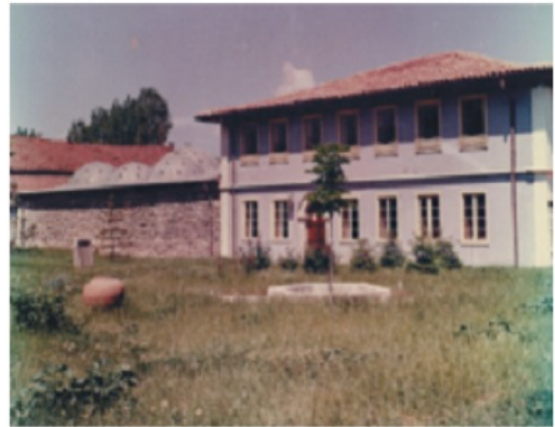
Technical condition of the Hammam is very bad. During rainfall, atmospheric waters and black-waters, penetrate flooding the floor up to 50cm and jeopardizing the structure. Also the roof of the Hammam is heavily damaged. As a consequence of atmospheric precipitation, the water penetrates in many places and endangers the construction of the roof, which is almost completely destroyed.

Poor condition of the interior in general and of the exterior in part. Penetration of water from the around and from the roof has damaged the interior walls and the floor.

Fair volume – structure of the object. As a consequence of bombings during the war – the walls have suffered cracks in several parts.

If we do not take the necessary sanitation measures, we will face the further alarming deterioration of the *hammam*.

Considering that the Mitrovice *hammam* expresses special cultural values, represents oriental architecture (Turkish public baths) and considering the high level risk of destruction of this object, we think that there are sufficient predispositions for a successful sanitation and restoration project.
