Architectural ensemble of the Old Soko mosque in Gračanica

Name and address of bulding(s) or site: ARCHITECTURAL ENSEMBLE OF THE OLD SOKO MOSQUE IN GRAČANICA

Inventory reference number(s): 06-6-91/03-2

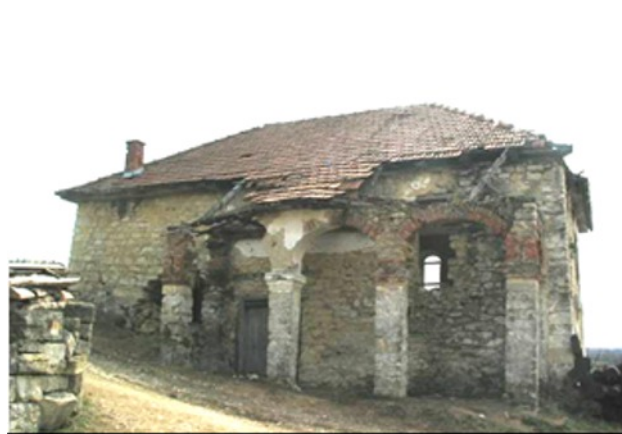
Since 1980 the Old Mosque in Soko is no longer used for its original purpose. The monument is in a ruinous state. The entrance portico has completely collapsed, the minaret has been pulled down and the stone used to build it is in the immediate vicinity. There are no surviving doors or windows, nor has the wooden interfloor structure survived; only traces are to be seen on the walls. The roof and walls are in very poor condition and in danger of collapsing.

For the purpose of preserving and ensuring the conditions for the rehabilitation of the mosque, the following urgent measures are stipulated to prevent its further deterioration:

1. conservation of the walls
2. survey and structural analysis
3. repair and structural consolidation of walls and roof;
4. protection of the mosque, in particular the walls, from the effects of the elements.

The minaret and entrance portico of the mosque shall be reconstructed, in the original form, with the original dimensions, of the same or same type of materials, using the same technical procedures wherever possible, while ensuring that the historical stages are clearly distinguishable.
