Monastery of the “Dormition of the Holy Virgin”

MONASTERY OF THE “DORMITION OF
THE HOLY VIRGIN”, Kakome, Saranda

Architectural monument, church

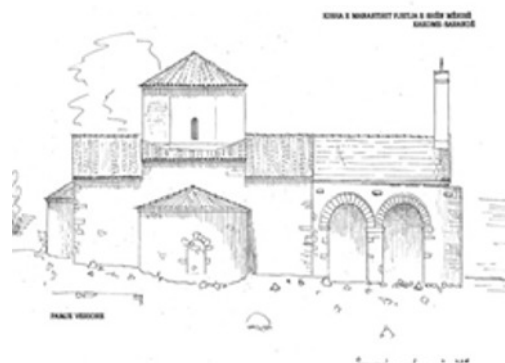
Poor: Both buildings are damaged. There is need for conservation works to reinforce the elements of the structure, and to restore the frescoes.

The Monastery of the Holy Virgin is situated in the Kakome Bay, one of the most picturesque landscapes of the Ionian sea, isolated from inhabited centers. The monastery is one of the most distinctive monasteries in the region because of its architectural and landscape values. The two monastery buildings are damaged and exposed to slow decay.
