Historic Complex of the Great Market

Name and address of building(s) or site: HISTORIC COMPLEX OF THE GREAT MARKET in Gjakovë/Djakovica, "Ismail Qemajli" street no.98

Building type(s): Residential building, Tower

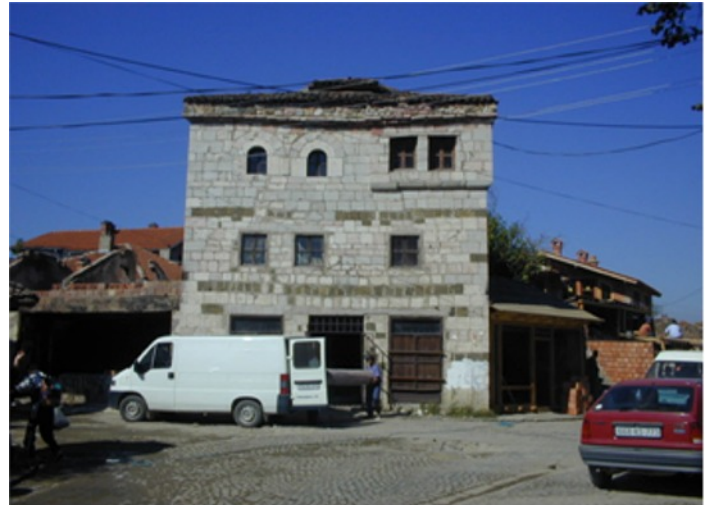
Bad condition: the tower is not in function, the roof construction is damaged, frontages on two sides are damaged, doors and windows and part of the roof construction are burnt. Interventions for the roof and the interior/exterior damage from fire are necessary.

The tower cannot be used for habitation because of cracks and the roof leaks.

The tower can be restored and made functional, the foundations and walls are sound and the monument could be used in accordance with its original residential function.
