The Red Church

THE RED CHURCH
Town of Perushtitza, located 2 kilometres
South-East of the town

Architectural Monument in ruins

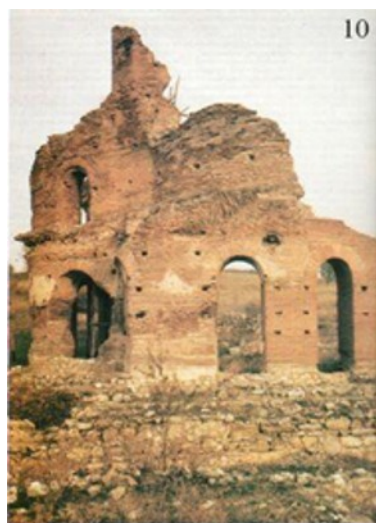
This type of church can be defined as a four-domed building with roundabout corridors and two narthexes. The preserved ruins provide data of three periods of construction. Part of the north dome of the main building is in good shape (up to a height below the dome arch), as well as the remains of two wall-painting layers dating back from the 6th and 11th centuries.

Good: structurally sound, with the exception of the partly conserved vault. Some small repairs, intervention for structure reinforcement and conservation of the wall paintings are needed.

Slow decay; solution agreed but not begun.

A technical assessment of the building condition and preliminary detailed costings have been carried out for repairs and rehabilitation, including structure and art conservation as well as the restoration works. The total estimated cost is about 40 000 Leva (20,000 €).
