## The Church of Saint Stephan

**Church of Saint Stephan, Shkodra**

THE CHURCH OF SAINT  
STEPHAN, Shkodra

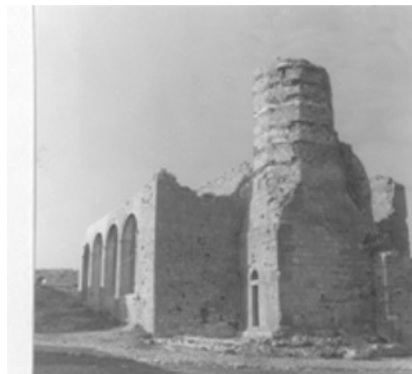
Bad: The perimeter walls, especially on the west side, show signs of structural problems. A rescue intervention had been carried out in 1987-88, but it did not ensure the stability of the structure for the future. There is a need for interventions on the roof, the walls and gothic architectural elements as well as the archaeological remains.

Because of its location in Scutari, one of the most important cities in northern Albania with rich cultural heritage, such as the castle of Rozafa, this church is of national interest. Interventions are needed to stabilize the wall structure, repair the roof and prevent damage from seismicity. A draft restoration project has been prepared but has not been implemented due to lack of funds.
